# Restoration Report

## IBM 3741 Data Station

Francesco Piva  
[Museo Didattico di Storia dell' Informatica](#)  
Padova, Italy

Padua, June 2000

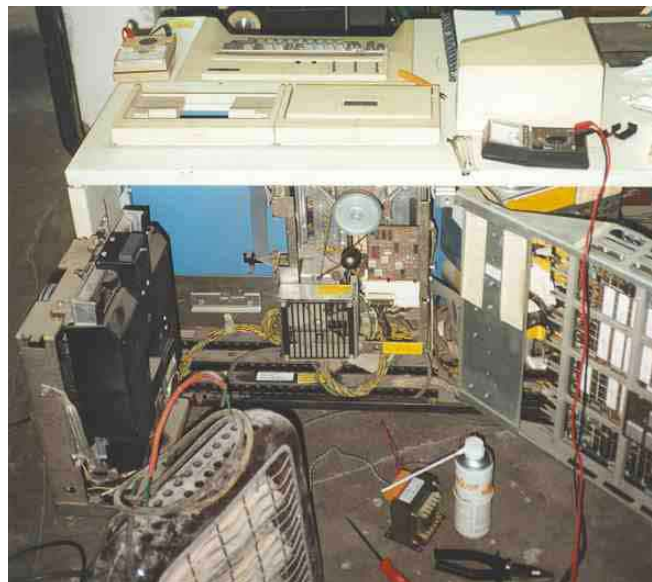
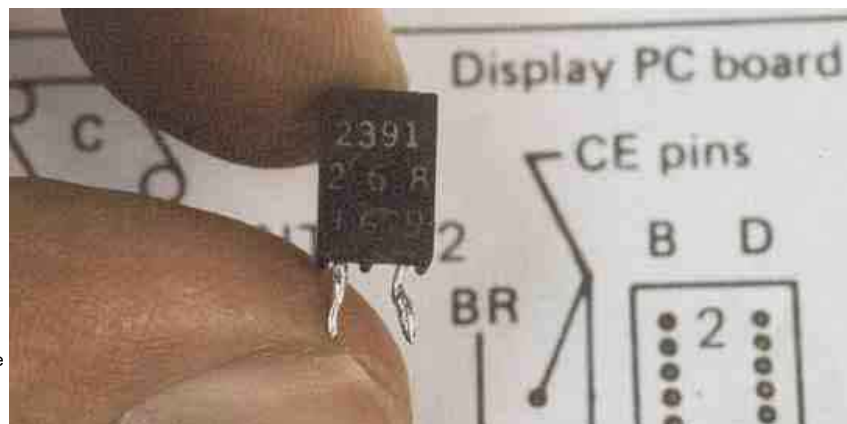
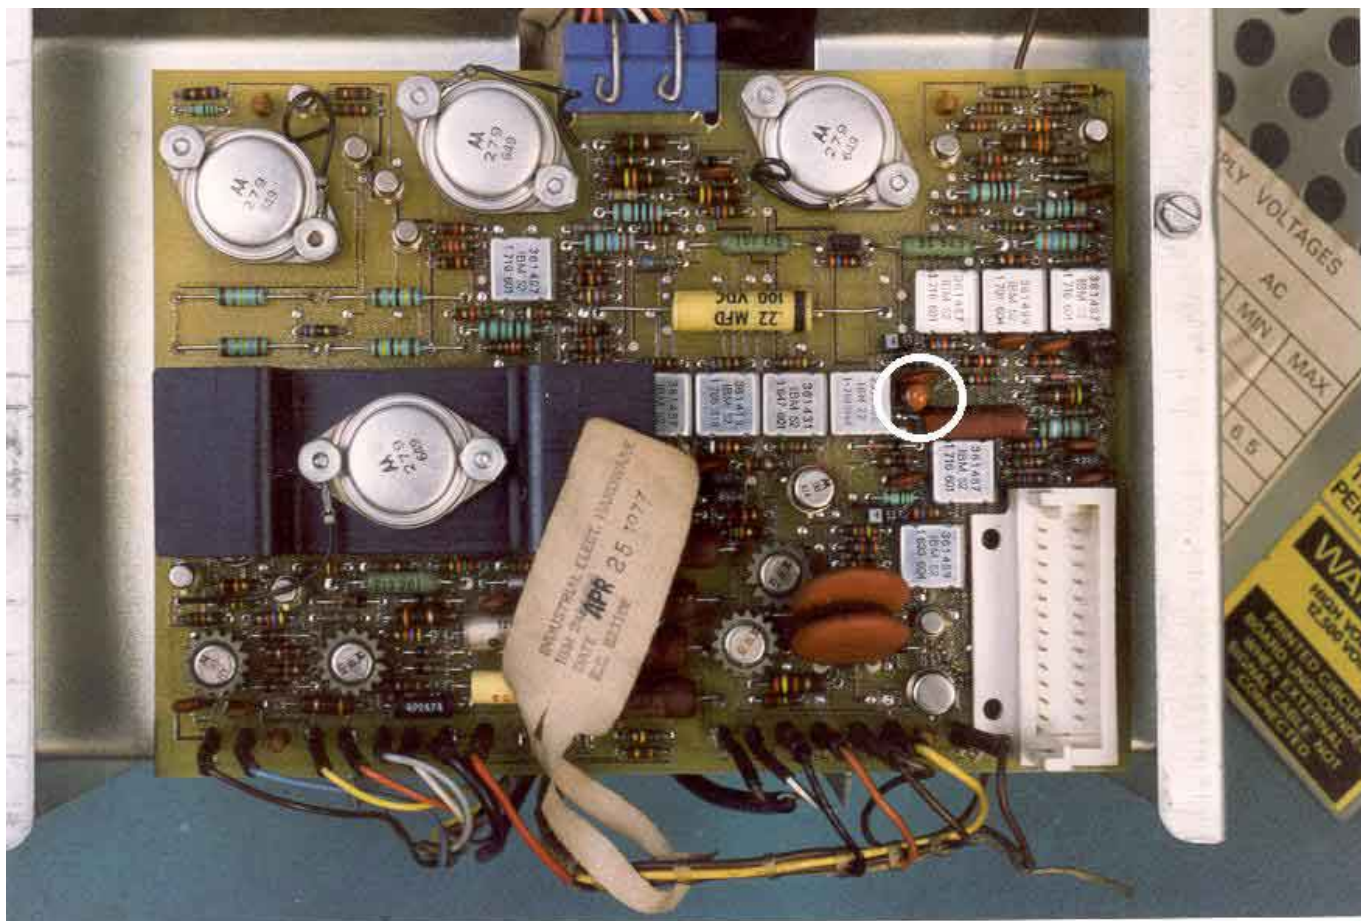
It must have been because Francesco and Martin both wanted to measure everything themselves that we found nothing. No shortcut, that is. That was on 17 June, 2000. We found an identical CRT in an IBM 5320 (System 32) and tried it. Same result, fuse blown. After excessive testing of the power supply which we drove to full load using heating wires we found that OK. So finally Martin measured again, this time finding a shortcut from the 12V line in the CRT unit to ground, tracing it down to an electrolytic capacitor.

Electrolytic capacitors age. Especially the ones that IBM used (non standard, of course) don't stand 12 Volts any more after 23 years. So when we turned on the machine, we short-circuited both CRTs. The reason that we blew only one capacitor and that we found it is that it was used as a power line bypass, with the full potential across it. Capacitors from timing circuits often are exposed to less voltage. Of course nobody had ever seen a capacitor like that (or have you?), and we could neither measure the capacity any more nor guess it from the stamped code (2391 268 1629). I heard that even the IBM Pensioneers Club does not have access to IBM's internal conversion charts.

**Addendum 17. Dec. 2000** I learned from [Henk Stegeman](#), who owns an IBM 3741 himself and is lucky to have pieces of the 'internal use only' documentation, that IBM P/N 2391268 is a tantaal, 6.8  $\mu$ F, 20Volt.

Normally, the CRT should work without bypass capacitors. To be on the safe side we put a 10 $\mu$ F 16V tantalum capacitor (white circle). On 20 June 2000 at 18:15, we turned it all on and... 25 seconds later we saw the status line appear on the screen. It worked!

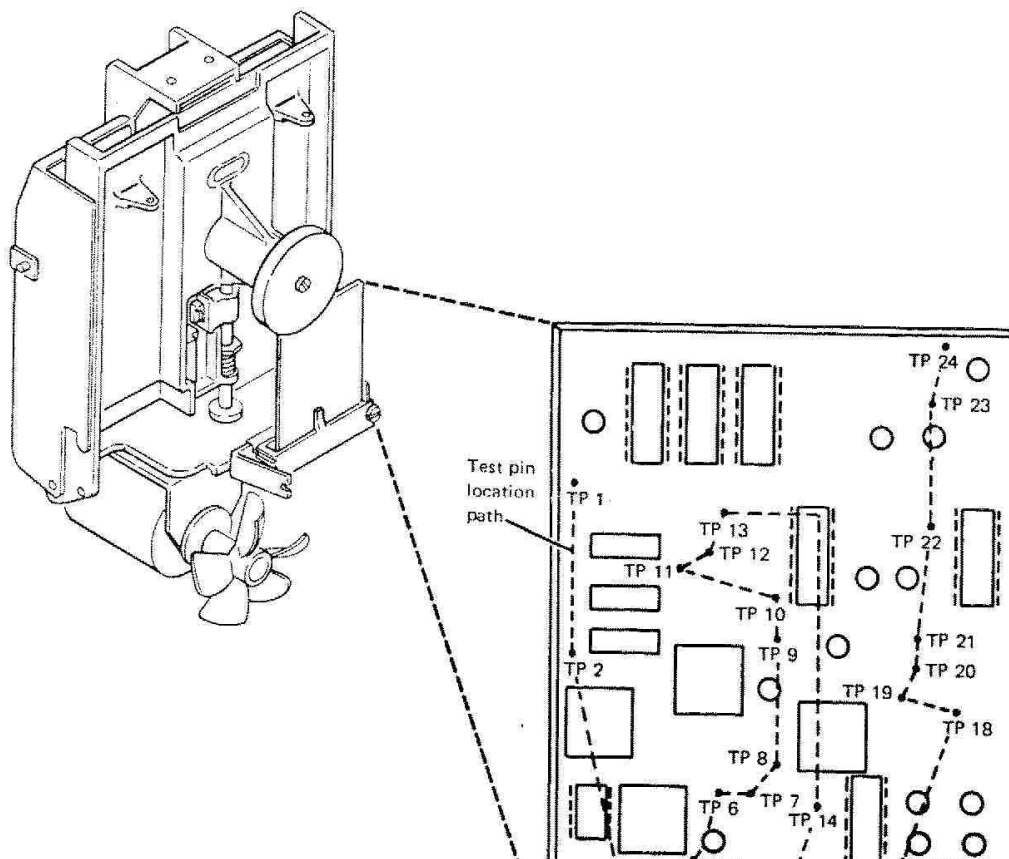
When we inserted a diskette, we heard the head load magnet click and saw an error code appear. Note that one-sided drives have a magnet-actuated pressure pad opposite the head. Obviously something was wrong. Same problem? This time, the manual held useful information: some test points (TP) on the File Control Card (FC card). That's a big name for a little electronics!

We found that 24V at TP 1 were missing, even though they were present at the main board. Moreover, the corresponding capacitor (!) was short-circuited. So that's where the burnt smell came from a week ago! Instead of blowing the 8A fuse in the 24V line, some circuit traces on the printed boards had burnt. They are much thinner than the fuse and extremely difficult to find and repair. A clear design flaw by IBM.

Luckily, we could borrow a 33FD drive FC card from an IBM 2502 Punch Card Reader, that's why we keep junk. We soldered out the critical capacitor **before** power-on this time. It had some 700 nF (code 2414 883 L646), so we chose new 1  $\mu$ F electrolytic capacitors for replacement (sponsored by Grundig). I don't know how the capacity may have changed with age.

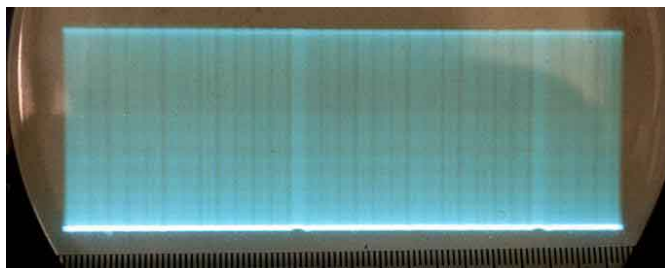
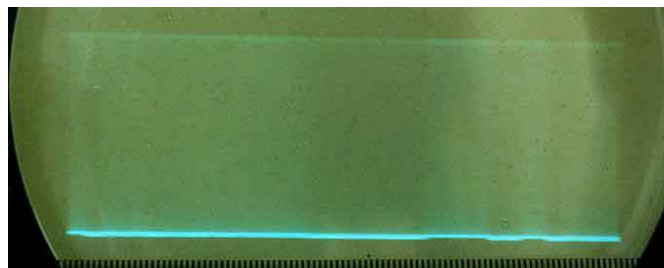
Here it is! What you see is a bit more than one track, the gaps between sectors showing as dark vertical lines (left picture). If we zoom onto one sector, we lose a lot of brightness. The data gap of the first and the ID gap of the following sector can yet be seen (to the right).

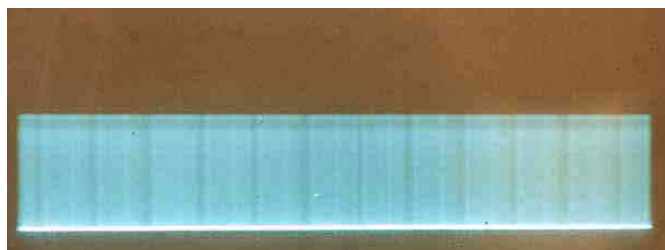
Head position adjusted

We can use this setup to check the head adjustment. First we get a nice clear image of some sectors (on the left), then we turn the stepper motor by hand. At  $90^\circ$ , we should reach the next track, so we expect something to happen in between. And rightly so! At a very narrow angular range ( $\pm 4^\circ$ ) around  $45^\circ$  we see interference patterns (spikes) from the information on neighbouring tracks (on the right). This means that the head adjustment is rather uncritical. It is normally achieved by simple mechanical means, but this also seems an efficient way.

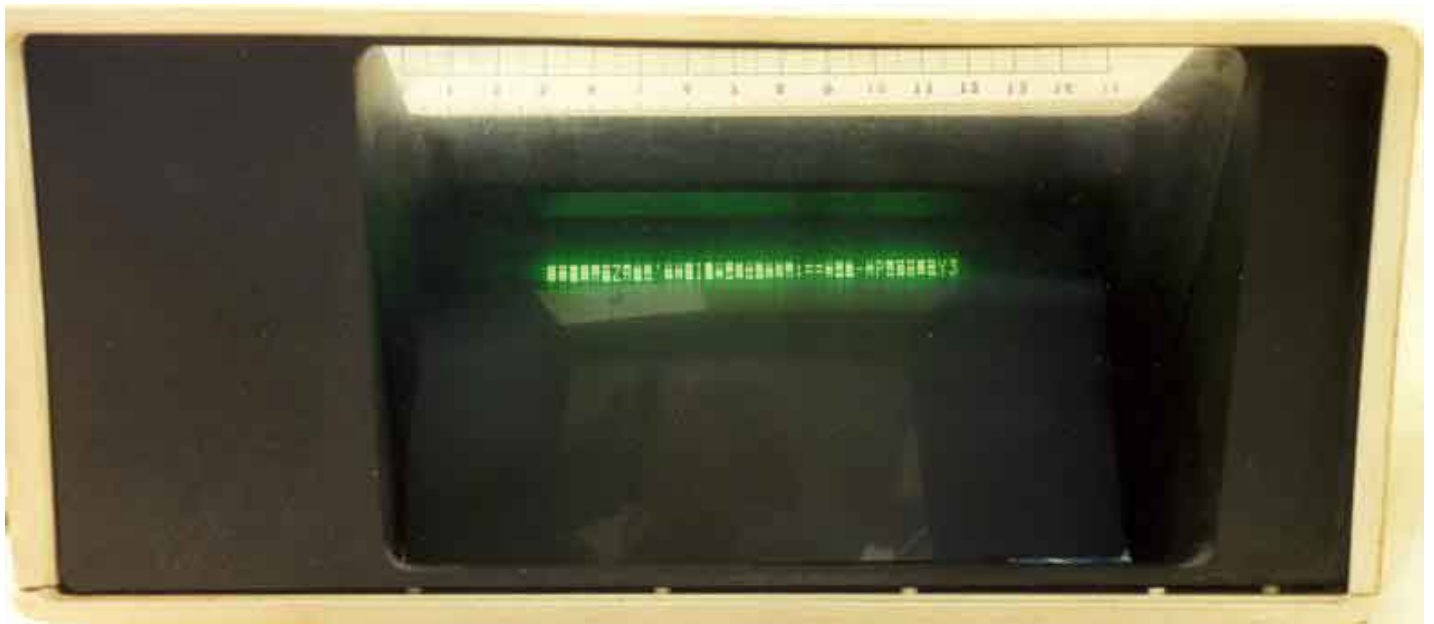
Finally, we were able to repair the CRT and floppy disk drive. Did the whole thing work then? No! Somehow we had ruined the main circuit board in the process, it would not carry out the reset procedure anymore. The keyboard kept on buzzing, the drive stepper motor didn't seek track zero and the screen showed this (the ruler laid in front of it):

What did we learn? The next time one plans to power up an IBM machine after over 20 years, it's advisable to

- a) disconnect everything from the power supply at first and to proceed step by step and
- b) solder out a bypass capacitor from the supply lines, at least at 12V and 24V, and try it at some overvoltage. (After measuring its capacity.)
