Hursley Museum Services – March 2019

Current Activities

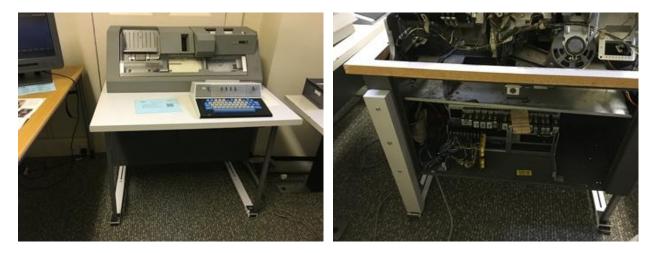
Our <u>029 card punch</u> has been fitted with a wooden leg. One of the back legs was damaged in transit from Oslo, and the initial fix proved to be too unstable. We are now looking for a parrot to sit on top.

The four punch & verifier machines on display now sit on appliance moving rollers that were surplus to requirements after my own home garage reorganisation. This means they can be easily pulled forward away from walls for access to the rear. The first practical use has been the 029, now that it is stable. It has received a full preventive maintenance; mechanically it appears to be sound apart from one of the two drive belts that has stretched. Unfortunately we don't have a spare but we might be OK for a while. There are still faults in the relay circuitry somewhere; fortunately we have found a wiring diagram on line and tracing continues!

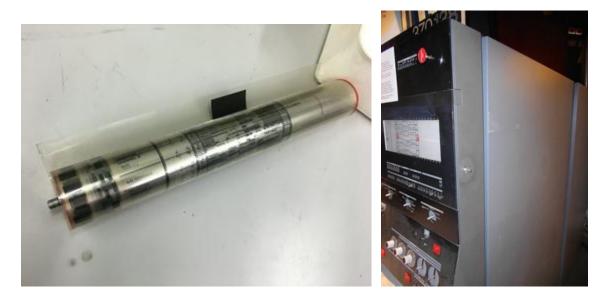
An artefact that has lain in a box in the back office for many years has finally been identified. It is a roll of clear printed litho film, with a gear wheel on one end and a small coiled spring in the other. Thanks to a couple of more detailed photos from Namur, we are now sure this is from the <u>operator console of a S/370 Model 138</u>, developed in Hursley.
