# Hursley Museum Services – March & May 2019

## Current Activities

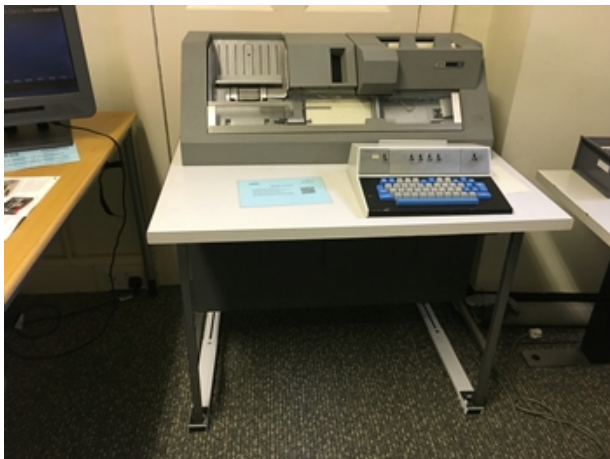
There were still faults in the relay circuitry somewhere; fortunately we found wiring diagrams on line and tracing continued. We discovered that none of these diagrams directly matched our machine, so finding a short circuit became tricky. Even though we'd already cleaned the relays and timing circuit breakers, my colleague Nick gave the CBs yet another thorough clean, and the short circuit disappeared.

At this point the punch clutch seized. This is a spring clutch, and the pulley had not been fully on so a coil of the spring dropped into the gap. Punch clutch springs are not the most common item to be held onto by an ex-CE, but another colleague Peter (the other Peter) just happened to have a bag of springs, including one punch clutch spring! Phew, saved again.

Whilst it now punched cards, the keyboard was extremely sluggish. A set of 44 tiny steel disks in a brass channel prevent more than one key being depressed at a time, and they become magnetised and oily over time. They were removed, cleaned, degaussed, spilled on the carpet and 41 subsequently found. Fortunately my box of washers contained a few of these from way back when I left the field in 1975. The keyboard feels great now.

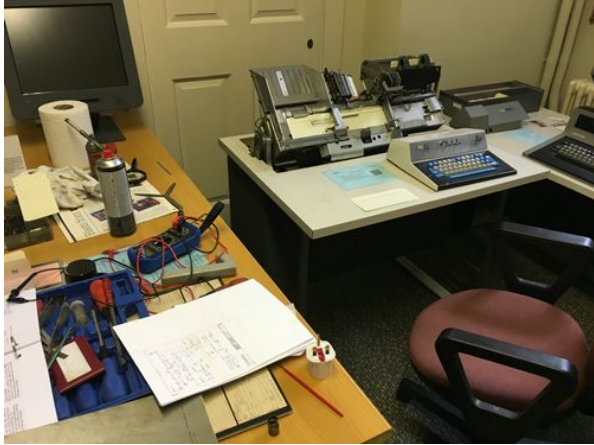
029

Our [029 card punch](#) has been fitted with a wooden leg. One of the back legs was damaged in transit from Oslo, and the initial fix proved to be too unstable. We are now looking for a parrot to sit on top...

The four punch & verifier machines on display now sit on appliance moving rollers that were surplus to requirements after my own home garage reorganisation. This means they can be easily pulled forward away from walls for access to the rear.

The first practical use has been the 029, now that it is stable. It has received a full preventive maintenance; mechanically it appears to be sound apart from one of the two drive belts that has stretched. Unfortunately we don't have a spare but we might be OK for a while. We've had no success with other IBM preservation groups, however we think that a 2L23 belt is a direct equivalent. So far no replies from any belt manufacturers.

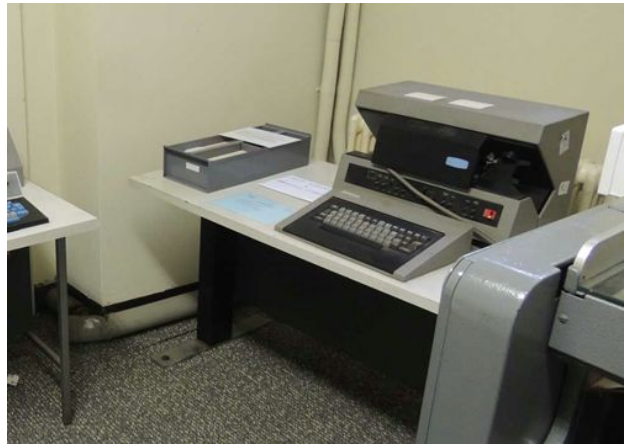
Sitting next to the 029 is the 5496 from Oslo, a buffered punch & verifier for 96 column cards. We have ascertained that it does still work OK, except the motor does not stop running after a few seconds. This is probably the micro switch on the top cover, and we'll try and sort that soon. We also need to do some revision how to create programmes – it's been a long time!

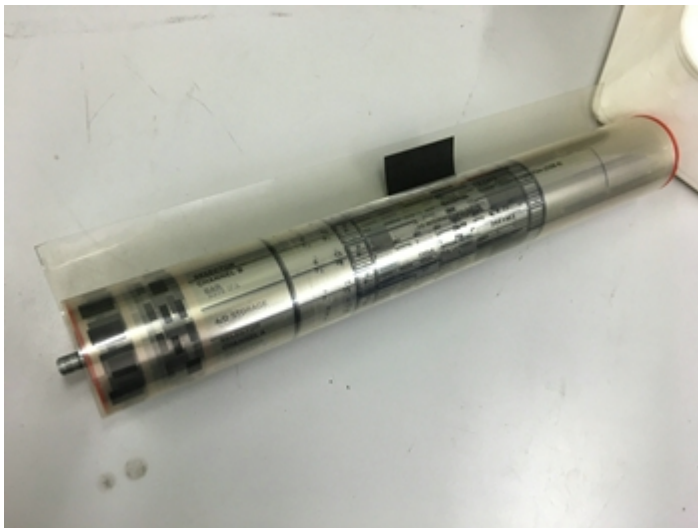
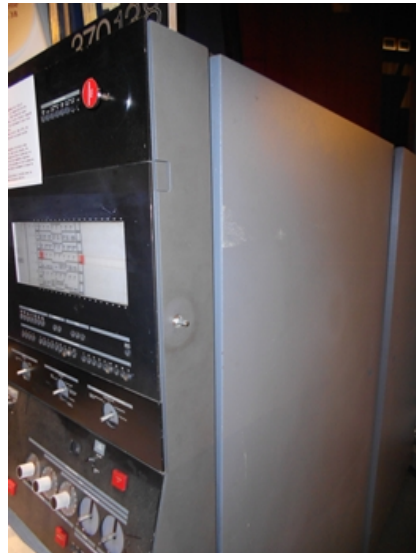
An artefact that has lain in a box in the back office for many years has finally been identified. It is a roll of clear printed litho film, with a gear wheel on one end and a small coiled spring in the other. Thanks to a couple of more detailed photos from Namur, we are now sure this is from the [operator console of a S/370 Model 138](#), developed in Hursley.
