# Restoration Report

## IBM 3741 Data Station

Francesco Piva  
[Museo Didattico di Storia dell' Informatica](#)  
Padova, Italy

Padua, June 2000

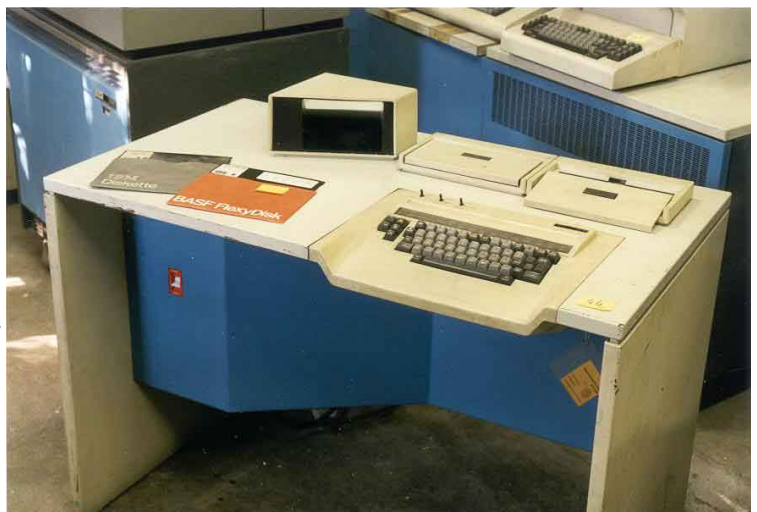
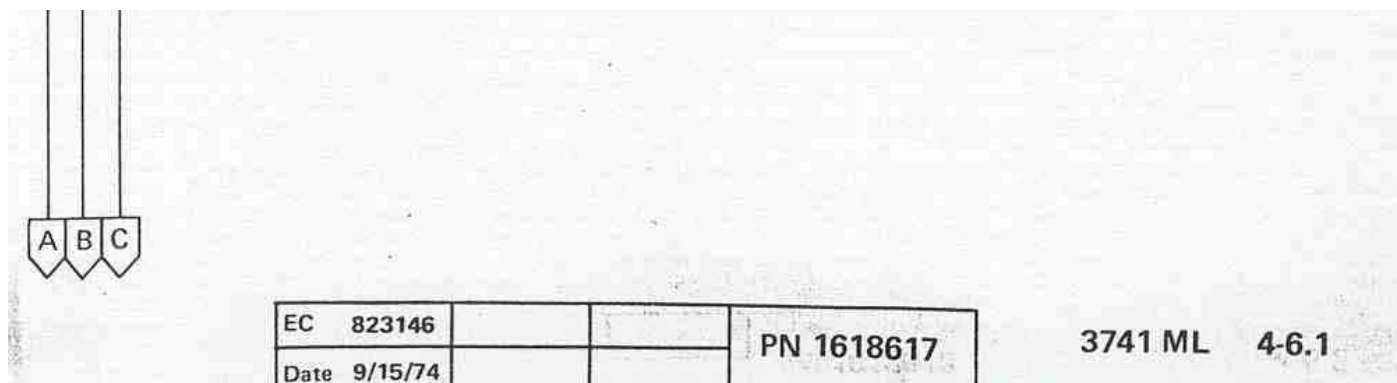
## MAP 4-6 —

As an example, look at Error Map 4-6. You normally get here when the buzzer either remains silent or is always on (as in our case when the reset process later gave out). Note the tolerances!

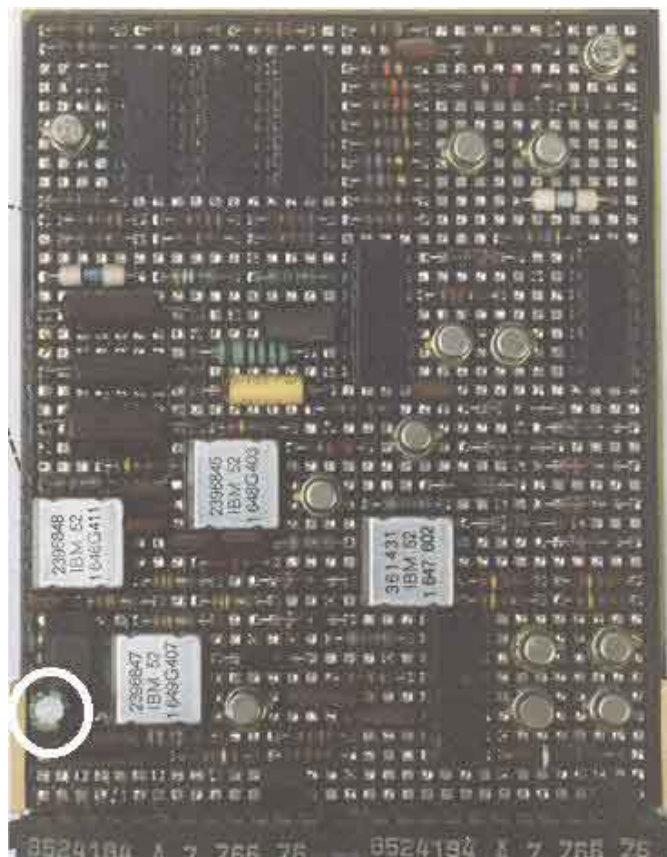
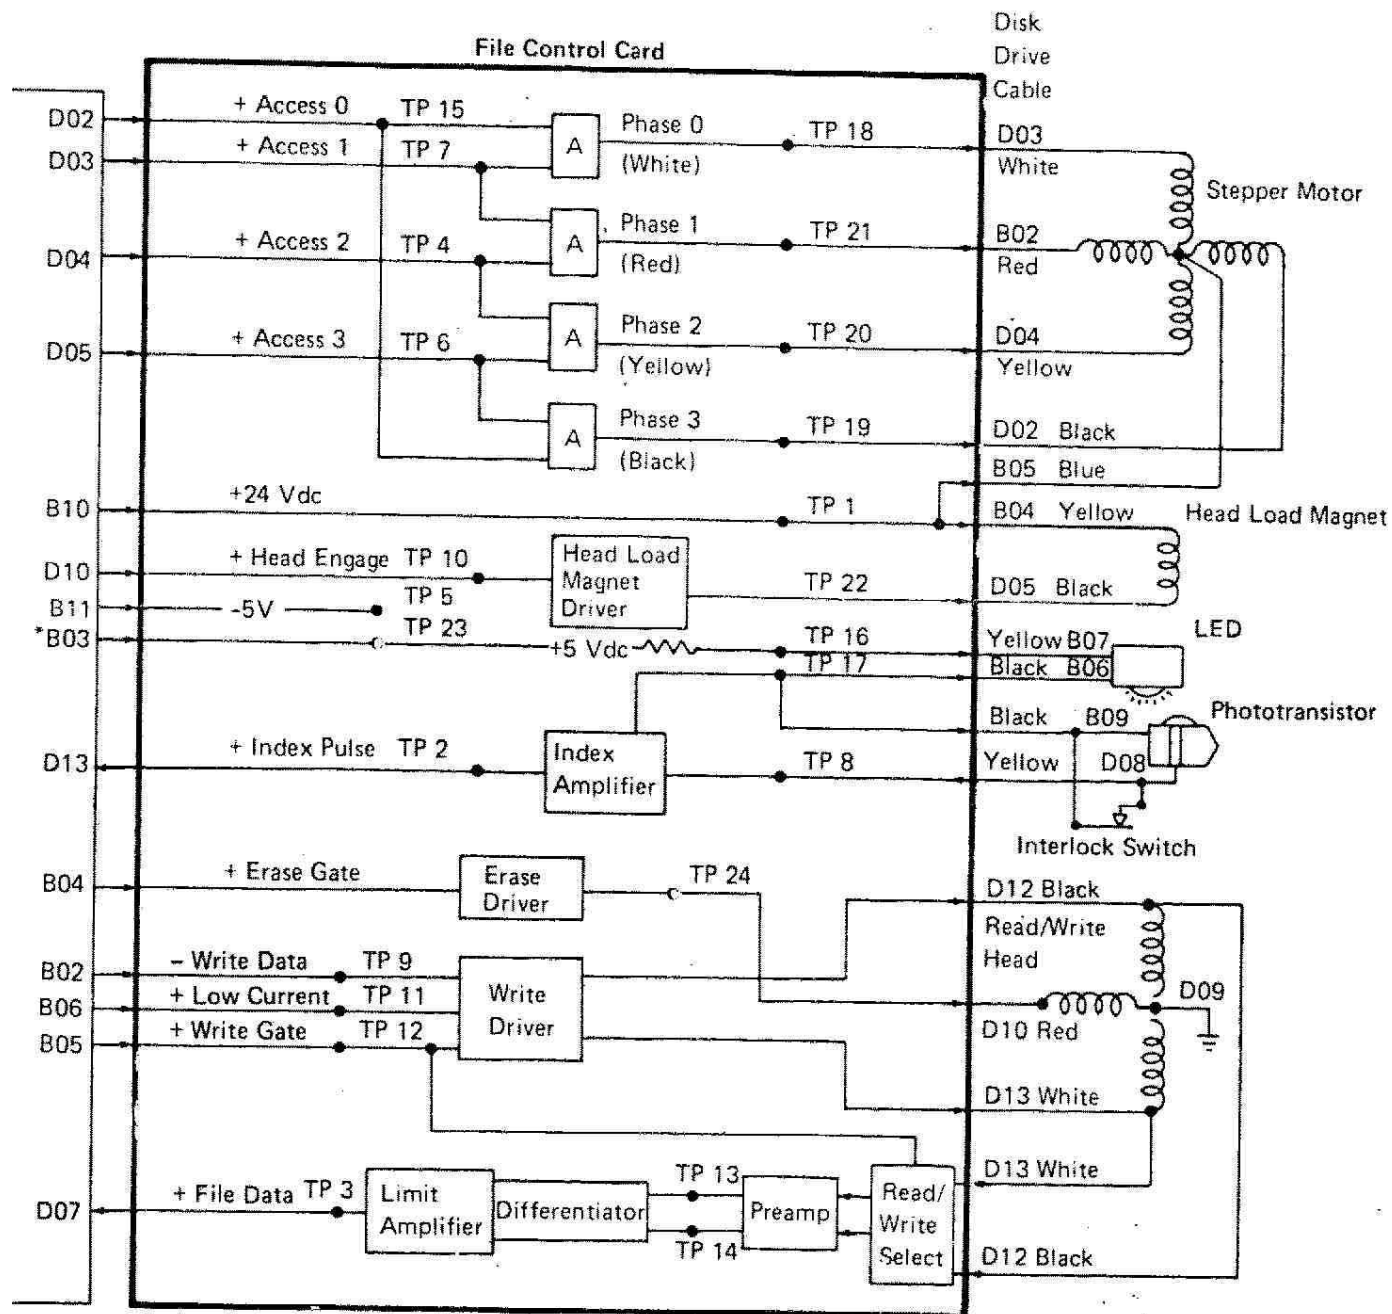
CE Test Points TP 13 and TP 14  
 20-400 mV (all 0's)  
 10-300 mV (all 1's)

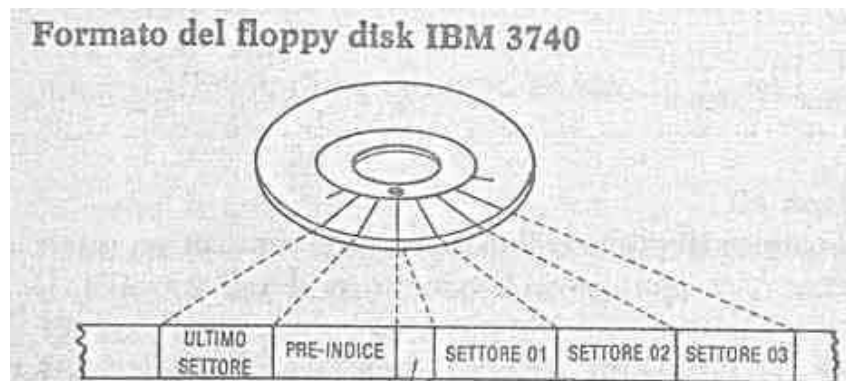
Note the relation between sector sequence and index hole as shown in the graph. We were able to observe directly ID and data fields and gaps. The gap lengths are:

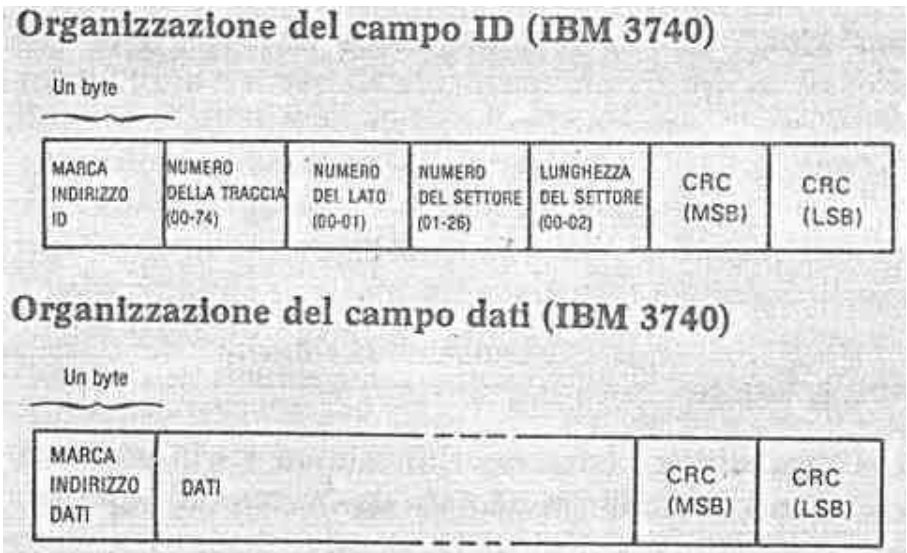
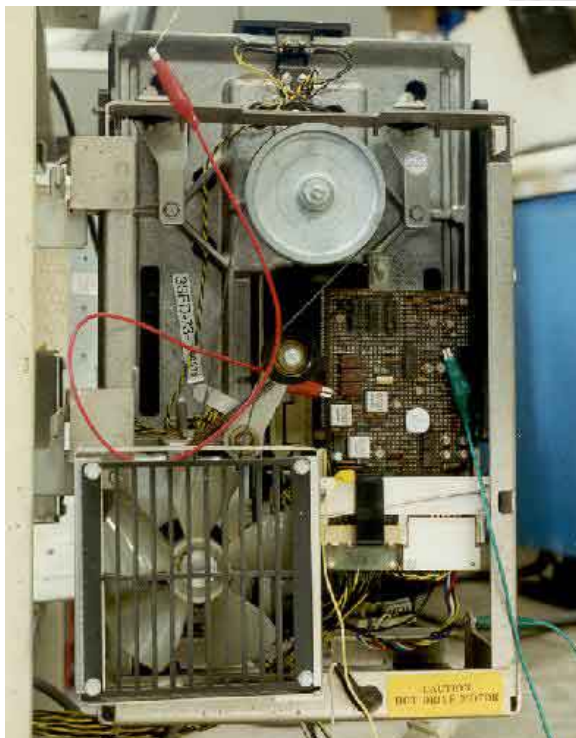
#### Experimental Setup

With a rather simple installation the confusing data format can be displayed very clearly. At TP 3, the FC card of the drive provides the digital data of about 1V Amplitude (yellow wire). All we had to do to display it on an oscilloscope. To hold the sectors in place on our screen, we used as external trigger the prepared pulse at TP 2 which contains the optical information from the diskette index hole (red wire). In order to get nice signals, the head load magnet had to be switched on, we connected TP 22 to frame ground (green wire).

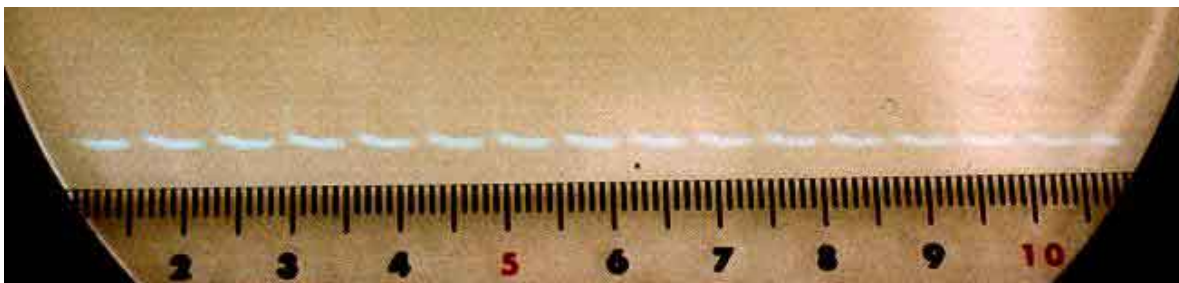
How far can this go? We don't expect to see single bits. The brightness would be insufficient, and also the index pulse trigger is probably not precise enough to synchronize the  $4\ \mu\text{s}$  cells. But let's try. The next image represents about one tenth of a sector, with the timescale set to  $8\ \mu\text{s}/\text{cm}$ . Indeed, we see a periodic signal with ten periods on  $6.4\ \text{cm}$ , corresponding to  $5.1\ \mu\text{s}$  each. Are these bit cells or not?!
