Preliminary description of the Prolay parts

Allen Palmer took a prolay apart (mostly)

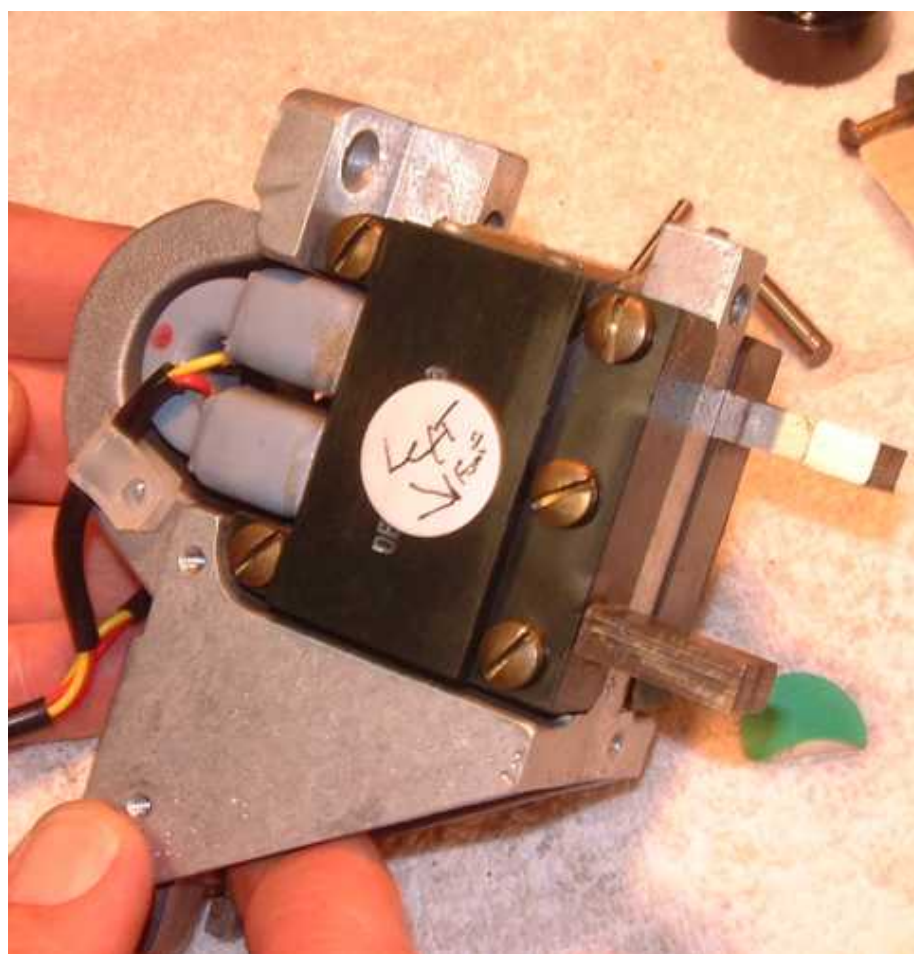
729 with left Prolay removed

The Prolay assembly moves to push the tape against the turning capstan to make the tape move.

To stop the tape, the Prolay pinch roller moves to *not* push the tape against the capstan.

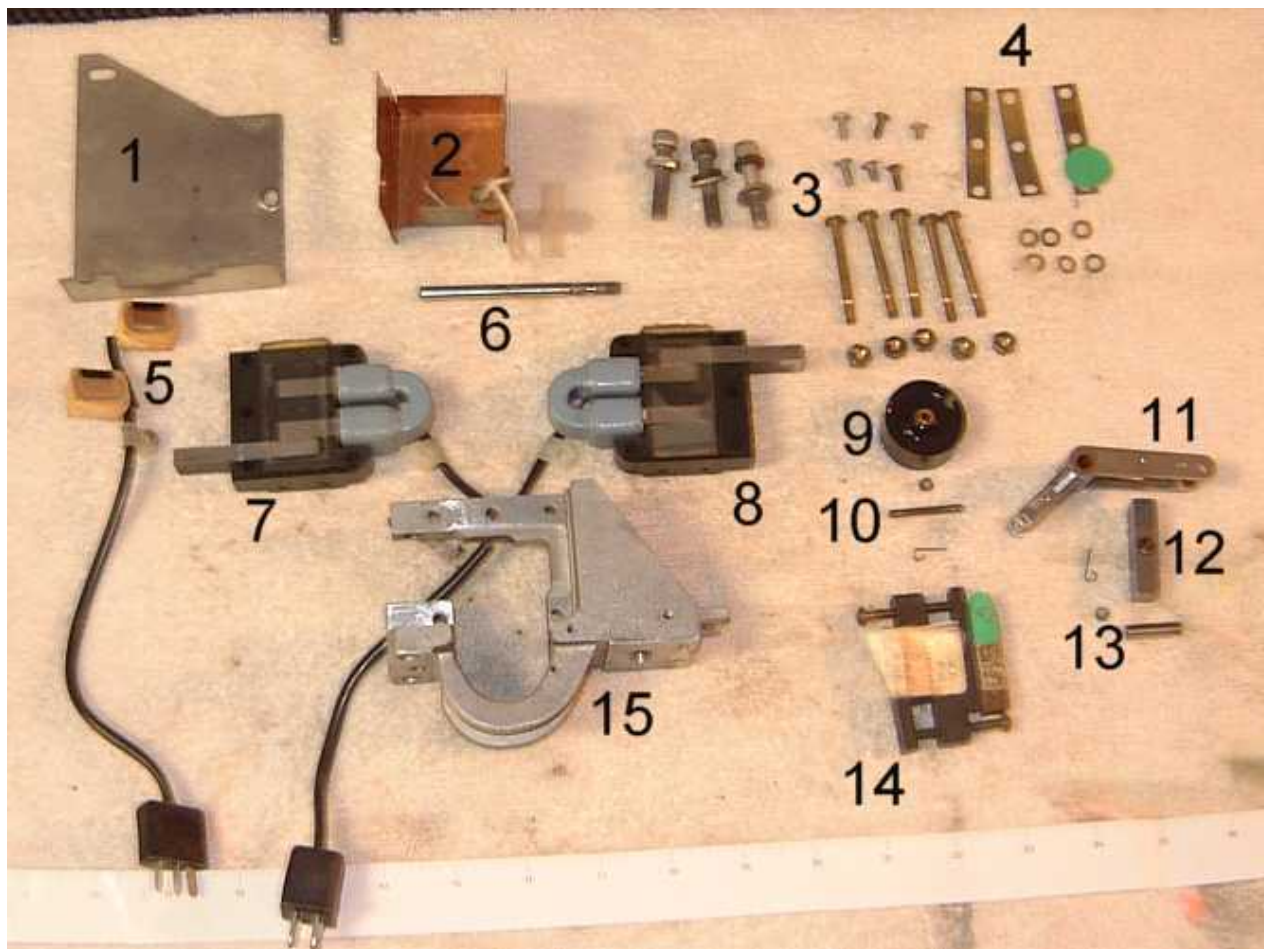
Left Prolay

The correct number of parts displayed is 64 :-))

1. Laminated metal shield, 3 layers, outsides stainless?, inside copper. One on each side of Prolay (One of these shields is missing) John Van Gardner (below) says that the outside metal of the three layer metal is [MuMetal](#) - a material that shields and reduces magnetic flux on the other side by permitting magnetic fields to easily go through it - acting as a "short circuit" to the magnetic field.

2. Shield to cover electromagnet coils 7 & 8 (thanks Allen) - the metal is two layers, "inside" is copper, "outside" maybe MuMetal
3. Fasteners
4. Shims** - 2 to 5 thousands thick

5. Neutral Coils** - to attract bottom of armature (12) to one side, and the top to the other side.
6. Pivot for Pinch roller arm (11)
7. Coil and iron to attract armature (12) to one side

8. Coil and iron to attract armature (12) to other side
9. Pinch Roller - this touches the magnetic tape, pinching the tape against the turning capstan, or not

10. Axis shaft and restraining hardware for pinch roller
11. Pinch roller arm, pivoted by (6), moved by armature (12)
12. Armature** (the laminated iron attracted to various magnetic assemblies)

13. Armature pivot for mounting it in the pinch roller arm, with restraining hardware
14. Neutral Core** - Iron and plastic for diagonal coils (5)
15. Prolay body - aluminum, non-magnetic

The AeroShell 14 was used a lubricant to prevent the fretting corrosion that occurred on the armature pivot. t occurs on any shaft that just rocks back and forth not rotating enough to keep the lubricant spread around the shaft. In the beginning we used IBM #6 and sometimes the armature would actually seize. There is also a good explanation of fretting corrosion on the internet at:

One for adding shims (he used a piece of IBM card) to give more travel to the arm causing more bite to the capstans. Prolays without the shims didn't last long before the minute amount of wear would reduce the bite.

With the wiring error, when the neutral coil was de-energized and the start coil energized, the collapsing field in the neutral coil was bucking the field in the start coil slowing down the armature movement. We reported the trouble to the plant but we never found out if that was the only cable that had the wires reversed.
