Hursley Museum Services – November 2023

Current Activities

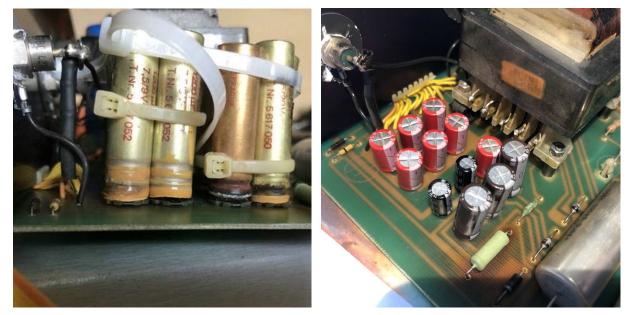
The 3279, the first colour terminal, developed in Hursley, joined the 3270 family in 1979. Our display model was powered up many years ago to the accompaniment of a very bad smell and otherwise nothing. We finally decided it was time we tried to get it working and so once again faced the inevitable power supply problem. A bank of 12 electrolytic capacitors was looking decidedly unwell, so the first job was to replace them. The photos show before and after.

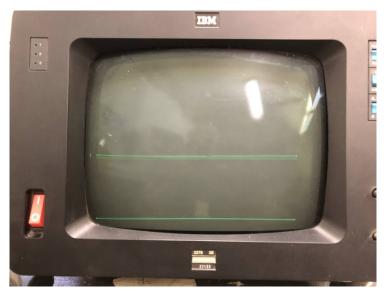
Unfortunately we still have problems, although there are at least signs of life now. This may still be a power supply issue as there are multiple voltages involved. However the solid green line at the bottom of the screen is fixed, and below which various status indicators would be displayed. The other line suggests a vertical driver issue, as it is a few mm deep and showing flickering.
